Construction evolution of medieval tuscan monasteries: The tie beam system in the Sant'Agostino monastery at Nicosia (Pisa)

Federico Cecchetti
Mauro Sassu

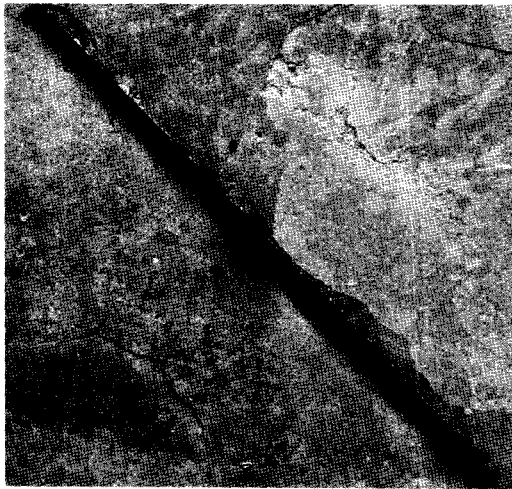
Figure 2
Tie beam anchorage (type n.1)

A survey of the tie heads, all of the «pole type», led to identification of three different types: the first characterized by very long, slender rods, with well-finished eyelets and very small tightening wedges (fig. 2).

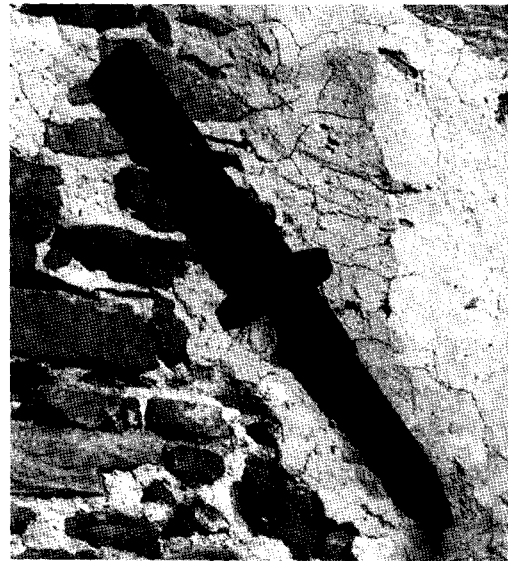
Figure 3
Tie beam anchorage (type n.2)

Another type of tie is instead distinguished by much shorter, thicker rods, with a wedge-shaped extremity, probably for easing its insertion into the

eyelet and whose tightening wedges are sometimes preceded by other metallic rods, with the function of tensing the tie and increasing the resistant section of the cross anchorage (fig. 3)

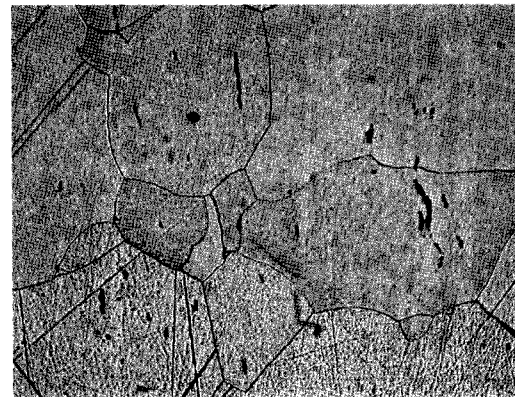
Figure 6
Metallographic view

The exams moreover revealed that the samples all have a rather large grain (see fig. 6), indicating a high concentration of impurities².

This exam enabled a first hypothesis regarding the metal's chemical composition to be formulated, in that observation by the optical microscope revealed that it is not composed of a two-element, iron-carbon alloy, such as steel, but soft iron with low carbon content.

Upon metallographic examination all the samples exhibited macro-inclusions at first visual inspection; these are probably attributable to incomplete decarbonisation during the iron production process.
